First conclusions about results of GPR investigations in the Church of the Assumption of the Blessed Virgin Mary in Kłodzko, Poland

Abstract. The article shows results of the GPR investigation in the Church of the Assumption of the Blessed Virgin Mary (XIV–XVI AD). Due to the wars in the 20th century, the majority of the documents connected with the church's history was lost. For this reason under the floor of the catholic temple, unknown structures might still exist. To verify the presence of underground structures such as crypts and tombs, a GPR survey was carried out in chapels and aisles with 500 and 800 MHz 15 GPR shielded antennas. During the investigation, numerous anomalies were detected. It was concluded that anomalies under the chapels were caused by the presence of the crypt beneath the floor. The presented work shows first results of GPR surveys in the church in Kłodzko.

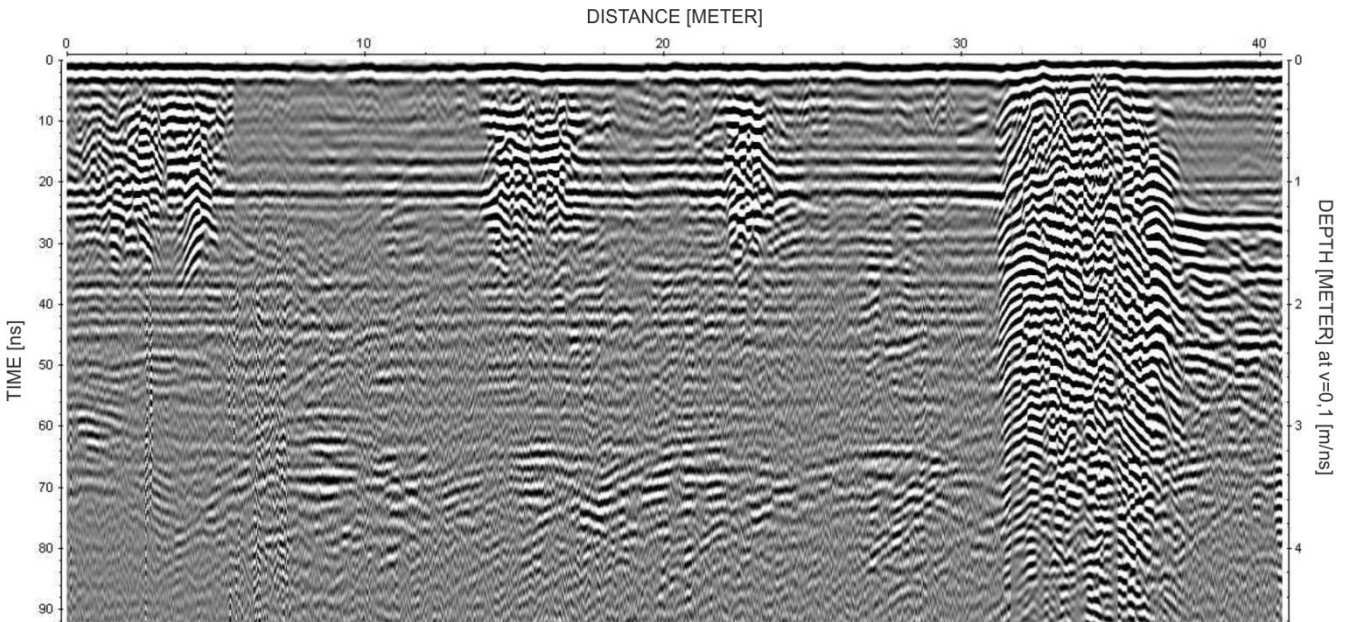
Several clear hyperbolic anomalies were indicated along the aisles at a depth of 50–75 ns (3–4 m) with both 500 and 800 MHz antennas. The shape of the reflector resembles a curve of 15 m radius circle according to the evaluation of the angle between branches of hyperbolic anomalies (e.g. PR 8 on Fig. 2). Shallow anomalies (2–20 ns) along the PR 8 profile (on the distance 2–5 m, 14–18 m, 22–24 m) are marked in the Fig. 1. These anomalies are probably caused by the foundations of the pillars (Daniels, 2004, p.356). Shallow anomalies and strong reflections at a distance 31.8–36.2 m are connected with elements of central heating system under the floor. According to the comparison of the data obtained along and across aisles and information about the setting of the former church, (www.klodzko.pl – Religious monuments, 2017), it is possible that reflections from 50 to 75 ns might be caused by a presence of foundation remains of a previous sacral building. Despite the fact that antennas were shielded these anomalies might be reflections from the ceiling of the church (vaults of the naves) (Daniels, 2004, pp. 335–339). Analysis of the velocity of the hyperbolic reflections gave values from the 0.25 m/ns to 0.30 m/ns. The shape of the reflections indicates the presence of diffraction.

Figure 2. Profile PR8, antenna 500 MHz

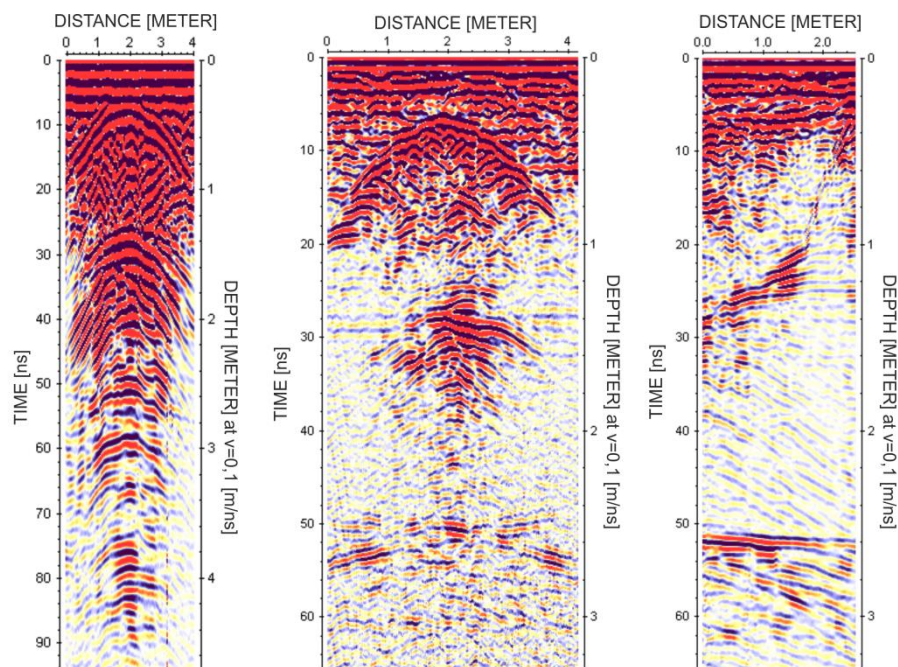
Radargrams registered with the 500 MHz antenna show hyperbolic anomaly at six ns (0.3 m). The anomaly is visible clearly on radargram from the PPR 14 profile (Fig.4 (a)). There is also another reflection visible at the 26–32 ns (1.2–1.6 m). Radargram from 800 MHz antenna shows also clear anomaly at 50 ns (2.5 m), which is more visible on the data from 500

MHz antenna. Figure 4 (c) shows radargram obtained along the P 9 profile which is perpendicular to the P 1 (Fig.4 (b)). The deepest reflection at time 50 ns is still visible. Reflection at 26 ns continues from the beginning to the end of the profile with changing depth.

The hyperbolic anomaly at six ns is interpreted as a reflection from the ceiling (vault) of the crypt. It is the most probable
5   interpretation of this anomaly. Such objects as crypts or tombs are common in the middle–aged catholic temples. In this church, there are more crypts which are marked on the ground floor plan, e.g. crypt under the PPR 19 and the PPR 20 profiles on Fig. 3 (b) (probably Count Montani's crypt). However, this crypt considered to be new, because there is no sign of it on the church sketches (Fig. 3 (a), (b)). The shape of the anomaly suggests that the entrance to it may be under the altar, on the outer side of the wall. The shape of this reflection also suggests that it might be connected with already known crypt
10   which is justified because in Fig. 4 (c) this reflection appears on different times. The shape of the anomaly from 26 ns may be classified by velocity pull-up (Conyers, 2014, pp. 31–35) and can be interpreted as a coffin in the crypt, or crypt's floor. The deepest anomaly from 50 ns could be defined as multiple reflections from the ceiling of the chapel. Another variant is that these might be remains of the previous church.

Probable dimensions of the discovered crypt are 3 m in width and 1.8–2.5 m in height. The velocity of the electromagnetic
15   wave in the crypt (0.3 m/ns) which is three times higher than the velocity in the ground, so the height of the discovered crypt is around 0.6–1.5 and that crypt is most probably filled with air.

Figure 4. (a) Profile PPR 14, 500 MHz antenna, (b) Profile P. 1., antenna 800 MHz, (c) Profile P. 9., (perpendicular to the previous one) antenna 800 MHz

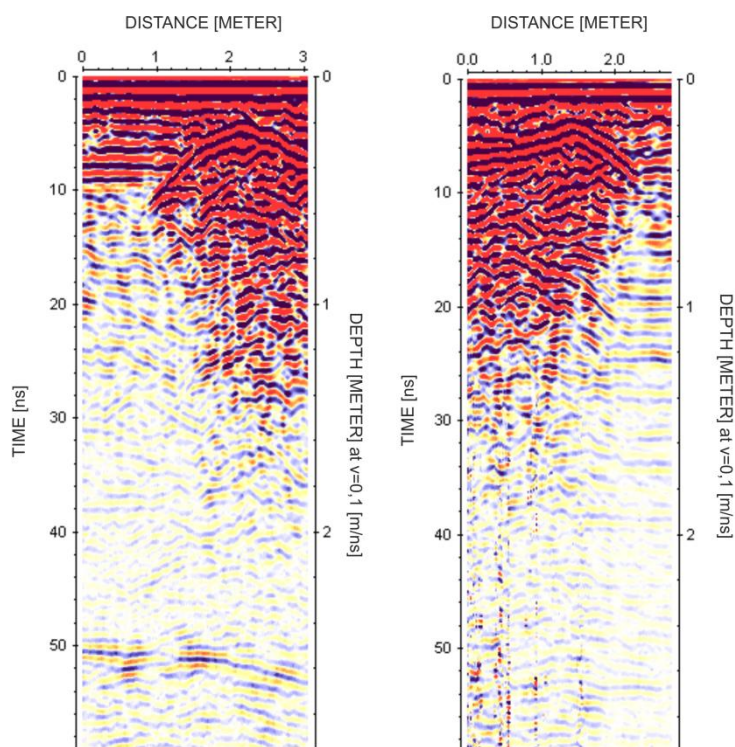
The hyperbolic anomaly at four ns (0.2 m) is visible on the radargrams from this chapel (Fig. 5 (a), (b)). The difference between similar anomalies (six ns from Dead People's Chapel) is that directly under the main reflection there are many
20   smaller disturbances. Like in the previous Dead People's Chapel, reflections at 50 ns are visible.

The main hyperbolic reflection at a depth of four ns (0.18 m) is interpreted as a vault of the crypt (Fig. 5 (a), (b)). The changes in the shape of the anomaly are associated with the direction of profiles. Vault can be described as a barrel vault or pointed barrel vault (Imposa and Grassi., 2015 ; Barilaro et al., 2007). In that case, on profiles crossing perpendicularly to its stretch a hyperbolic anomaly was detected (Fig. 5 (a)). Radargrams collected parallel to the stretch of the vault showed flat
25   reflections (Fig. 5 (b)), because the shape of the crypt's ceiling was lateral under them.

Probable size of the crypt is 2 m in width. The crypt is also a newly discovered underground object. Because of the shape and location of the anomaly, expected entrance to the tomb is outside the chapel.

Figure 5. (a) Profile P5, antenna 800 MHz, (b) Profile P8, antenna 800 MHz
