The Impact and Resolution of the GPS Week Number Rollover of April 2019 on Autonomous Geophysical Instrument Platforms

Shane Coyle¹, C. Robert Clauer^{1,2}, Michael D. Hartinger³, Zhonghua Xu^{1,2}, and Yuxiang Peng¹

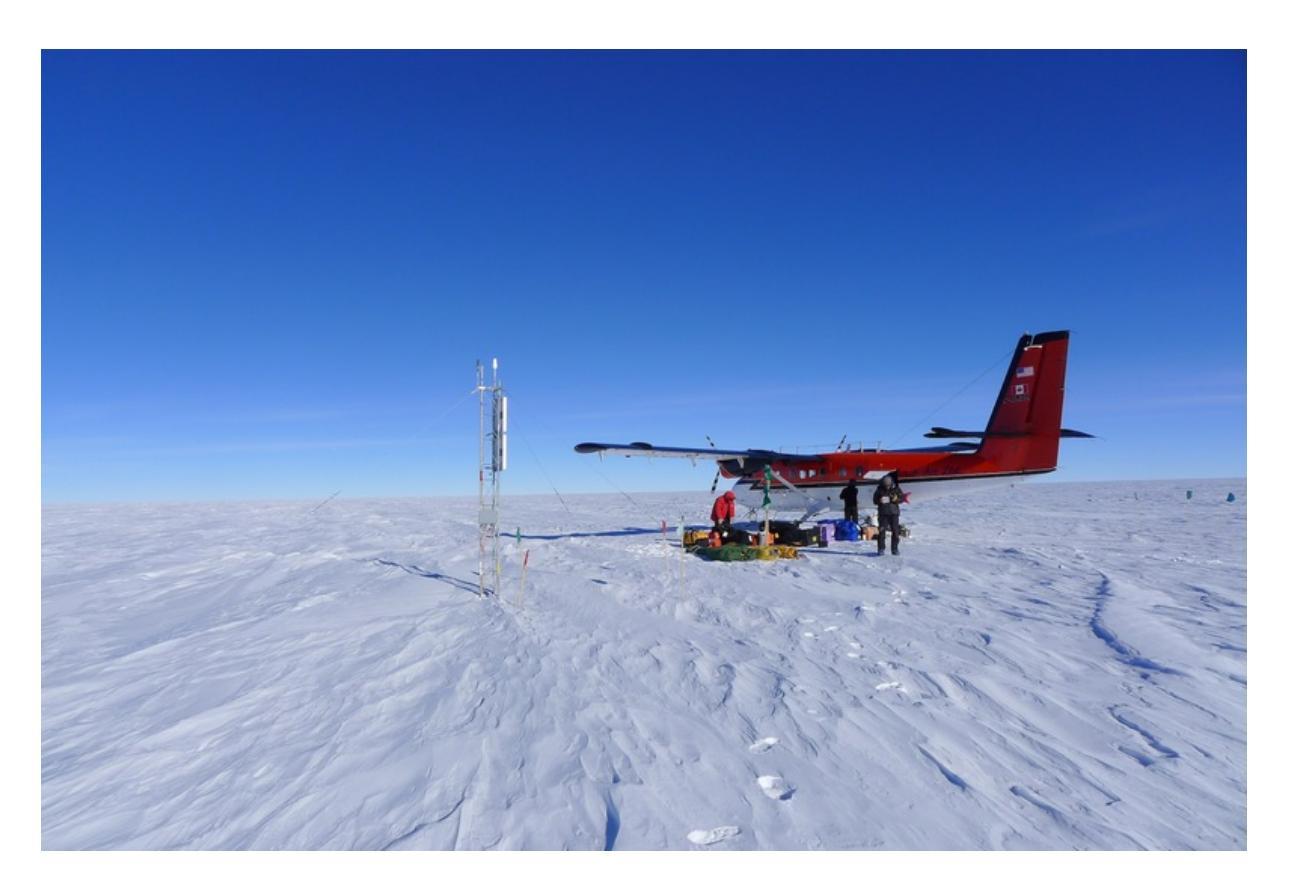
Figure 1. Twin Otter airplane next to the AAL-PIP system at PG2 (84.42 S, 57.96 E). The extreme environment and remote nature of the AAL-PIP sites makes in-person maintenance very difficult.

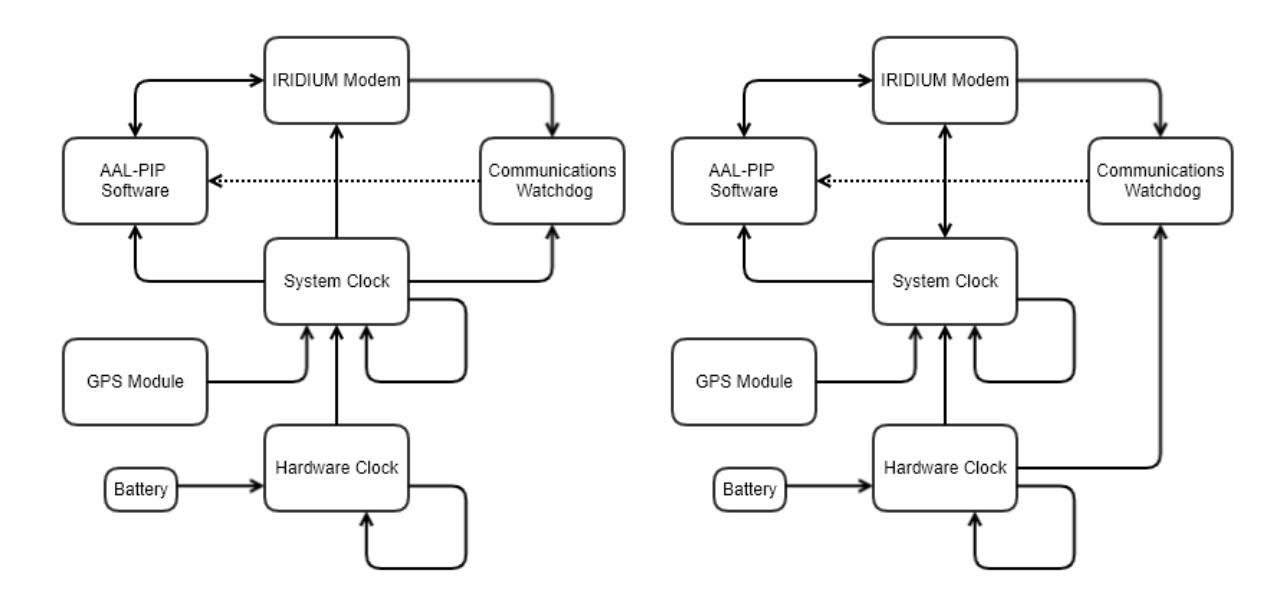
Figure 2. Diagrams contrasting the original flow of time information on the AAL-PIP systems (left) with the current method (right). Note the use of the hardware clock as an input for the communications watchdog, as well as the availability of IRIDIUM network sourced time for the system clock.

In the case of the AAL-PIP system, there are two important software design considerations that had to be addressed during the patch process. First, the communications watchdog timer issue had to be resolved. Typically, the watchdog will automatically 215 reboot the system after either staying connected or disconnected for more than 24 hours. When the watchdog first starts, it obtains the current time and then sets a trigger for 24 hours later. This reboot process was prevented by rolling the clock back to a time several years before the trigger time. A different, more robust solution to using the full date & time for timers like this would have been to strip the date from the trigger. However, this can still lead to some confusion as a result of making adjustments to the system clock. Using a monotonic hardware clock for this timer would provide a more robust solution, as 220 these clocks typically are not adjusted by any software process.
