Observation of the rock slope thermal regime, coupled with crackmeter stability monitoring: initial results from three different sites in Czechia (central Europe)

Ondřej Racek^{1,2}, Jan Blahůt², and Filip Hartvich²

Abstract. This paper describes a newly designed, experimental, and affordable rock slope monitoring system. This system is being used to monitor three rock slopes in Czechia for a period of up to 2 years. The instrumented rock slopes have different lithology (sandstone, limestone, and granite), aspect, and structural and mechanical properties. Induction crackmeters monitor the dynamic of joints, which separate unstable rock blocks from the rock face. This setup works with a repeatability of measurements of 0.05 mm. External destabilising factors (air temperature, precipitation, incoming and outgoing radiation, etc.) are measured by a weather station placed directly within the rock slope. Thermal behaviour in the rock slope surface zone is monitored using a compound temperature probe, placed inside a 3 m deep subhorizontal borehole, which is insulated from external air temperature. Additionally, one thermocouple is placed directly on the rock slope surface. From the ti

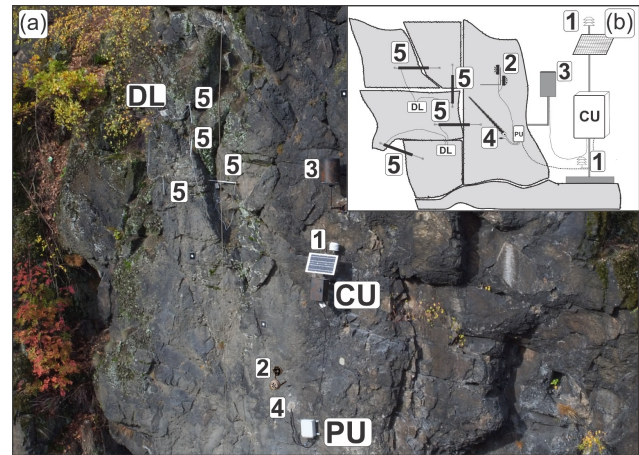
Figure 1. Photo of the monitoring system at the Tašovice site: (a) generalised scheme of the monitoring system (b) CU: control unit, PU: processing unit, DL: datalogger, 1: temperature sensor, 2: pyranometers, 3: rain gauge, 4: borehole compound temperature probe, 5: crackmeters (only four of a total of six crackmeters are visible on this photo).

strumentation on various rock slope sites. All sensors were calibrated by the manufacturer before they were installed on the rock slope to provide precise data. The monitoring system (Table 1, Fig. 1) is composed of the following components:

- a set of automatic induction crackmeters, coupled with dataloggers (Fig. 1) measuring relative block displacement;
- a weather station with a set of sensors measuring various meteorological data (Fig. 1), such as air temperature, humidity, and air pressure (Table 1), and surface solar radiation balance (incoming/reflected radiation) of the rock face (Fig. 5) using a pair of pyranometers;

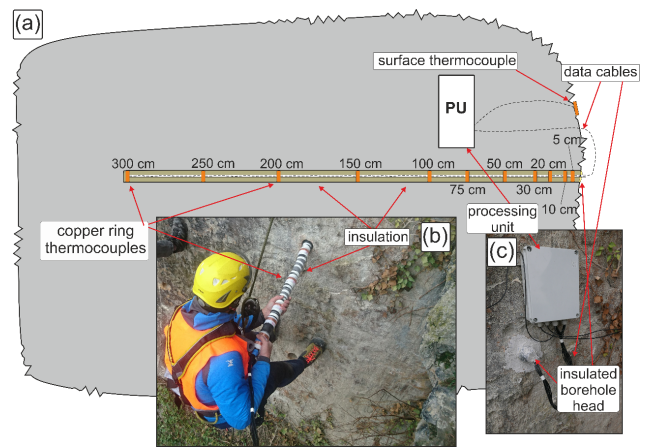
Figure 2. Compound borehole thermocouple probe: (a) generalised scheme, (b) photo of compound thermocouple probe installation, (c) insulated head of a subhorizontal borehole with a processing unit.

For the monitoring of the thermal behaviour of a rock slope, it is necessary to know temperatures at different depths of the rock mass. The newly designed in-depth compound temperature probe (Fig. 2) is a crucial part of our monitoring system. The sensors are placed in a 3 m deep subhorizontal borehole. To ensure safety during drilling and the long lifespan of the borehole and sensors, the borehole itself is drilled into a stable part of the rock slope. The borehole is then equipped with a custom-designed probe with a set of thermocouples. The technical parameters of the temperature sensors are the same as for the air temperature sensors (Table 1). The thermocouple sensors that are connected to copper rings were originally designed for soil temperature measurements. By connecting these to copper rings, they become suitable for measuring the temperature of borehole walls. Copper rings with 5 cm diam-

eter are placed at a given distance on the tubular spine (5 cm below the surface, 10, 20, 30, 50, 75, 100, 150, 200, 250, and 300 cm). The probe is placed in the subhorizontal borehole, so the copper rings containing the temperature sensors lay directly on the borehole walls (Fig. 2). This ensures that the probe is directly measuring the rock mass temperature. Additionally, one thermocouple is placed directly on the rock surface (Fig. 2). The head of the borehole is insulated to prevent air and water inflow into the rock and the sensors inside the borehole are separated by thorough thermal insulation to ensure that the temperatures are not affected by the air circulation inside the borehole. Therefore, temperature readings from the borehole compound probe correspond to the in situ rock mass temperature. The thermal data, collected every 10 min, are passed through a converter and sent to the main control unit of the environmental station.

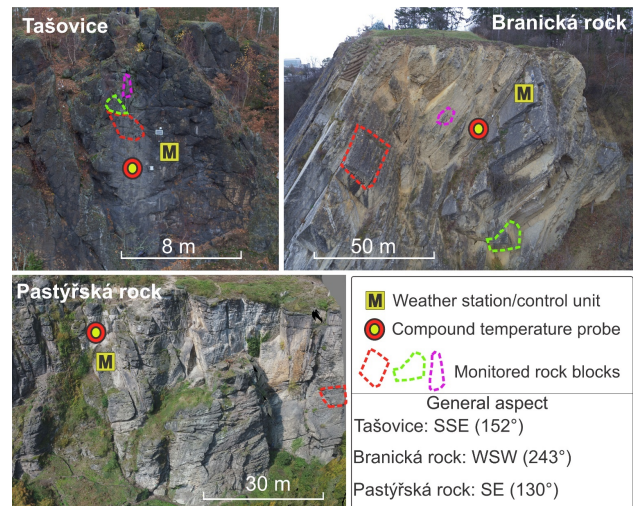
Figure 3. Three instrumented rock slope sites. On each photo, the monitored rock blocks are indicated with dashed lines of a different colour. The placement of the compound borehole temperature probe and weather station is also indicated.

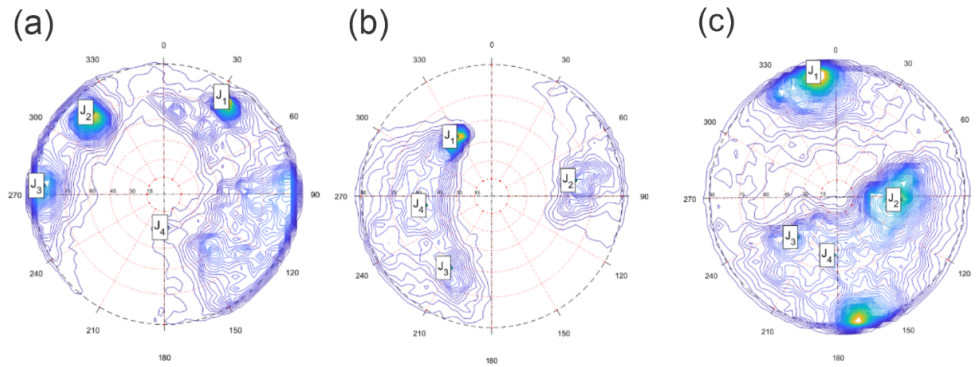
Figure 4. Stereonets with the four main discontinuity sets (J1–J4) classified using DSE software (Riquelme et al., 2014). The density of the principal poles corresponds to the main discontinuity sets identified from the point clouds. (a) Pastýřská rock, (b) Branická rock, (c) Tašovice.

From the discontinuity analysis (Fig. 4), it is possible to see that in the case of the Pastýřská and Branická rock sites the discontinuity systems are clearly defined. The discontinuity sets at these sites are defined mainly by sedimentary layers and cracks perpendicular to them. In the case of the Tašovice site, the discontinuity systems are less pronounced. At this site, discontinuities are linked mainly to tectonically predisposed weak zones and weathered parts of the granite rock. The mechanical properties of the rock mass samples (Table 3) differ significantly according to the degree of weathering. The best results in terms of hardness were obtained from the unweathered limestone from the Branická rock site. The lowest hardness was determined for the weathered sandstone from the Pastýřská rock site. At the Tašovice site, it was not possible to call an unweathered sample due to the high degree of weathering of the whole rock slope.

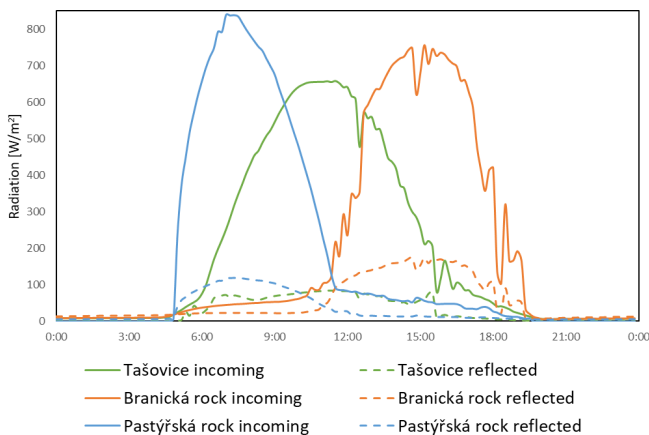
Figure 5. Example of the incoming and reflected radiation measured by the pyranometers at the Branická, Tašovice, and Pastýřská rock sites. A 24 h time series of incoming and reflected radiation is displayed. Data were recorded on 1 August 2020 with no clouds. The influence of the slope aspect is obvious from the incoming radiation peak shift.

The rock surface solar radiation balance was monitored at the sites in 2020 (Branická rock in January, Pastýřská rock in February, and Tašovice in December). Even from these incomplete data, it is possible to observe the differences between the individual sites (Fig. 5). Local conditions influence the incoming radiation pattern based on the general aspect of the rock slope (temporal shift of incoming radiation peak), rock slope albedo, or the shading effects of the surroundings of the pyranometers. Differences in the absolute reflected radiation are mainly caused by the different colours of the rock faces and by the different angle of incoming solar radiation due to the aspect of the instrumented slab.

Solar radiation balance is not directly comparable due to the different aspects and slopes of the instrumented rock slabs. However, the temporal shift in maximum radiation caused by the rock slope aspect is visible from the solar radiation chart (Fig. 5). When complete annual data on the solar radiance will be available (summer/autumn of 2021), a thorough investigation of the differences will be performed. Con-

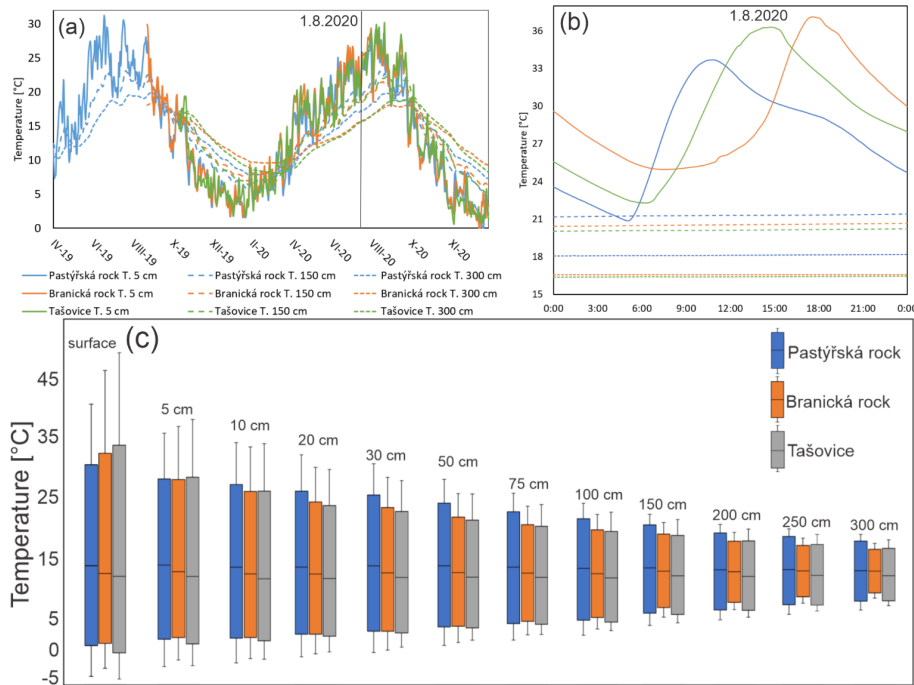
Figure 6. Comparison of temperatures at different rock slope depths (5, 150, and 300 cm) at the three monitored rock slope sites: **(a)** long-term data (daily average) and **(b)** 1 d data from 1 August 2020. In-depth annual **(a)** and diurnal **(b)** temperature amplitudes are displayed. In-depth rock mass temperature data are from all three monitored sites. Boxplots shows median, minimum, maximum, first, and third quartiles of temperature data. Temperature amplitudes from the compound borehole temperature probes may be compared between sites. At all sites, a decrease in the temperature amplitude with depth is apparent **(c)**.

By continuously measuring the temperature at different depths inside the subhorizontal boreholes, it is possible to observe both diurnal and annual temperature amplitudes at various depths (Fig. 6). In-depth temperature measurements show differences in the temporal thermal behaviour between the monitored rock slopes (Fig. 6). From the boxplots that

represent data from all of the monitored sites, it is possible to see that the largest surface temperature variation was measured at the Tašovice site. This is probably caused by the dark colour of the Tašovice rock surface, with lower albedo. However, at greater depths, this variation decreases. This is probably caused by the lower thermal diffusivity of the granite. Moreover, in the depth of the rock mass, the influence of direct sunlight is attenuated. Greater in-depth temperature variation is present at the Pastýřská rock site. However, these data may be biased by different time-series lengths (1 vs. 2 full years). The effect of different aspects may be seen in the peak of the diurnal temperature, when the temperature peaks earlier on the east-facing rock slope (Pastýřská rock) than on the SSE-facing Tašovice and WSW-facing Branická rock sites (Fig. 6). Differences in lithology (different thermal diffusivity) cause a temporal shift between surface and

subsurface temperature peaks. This temporal shift differs between the different rock slopes. A higher median of the in-depth temperature at the Pastýřská and Branická rock sites (Fig. 6) is caused by longer in-depth temperature time series spanning over two summer periods.

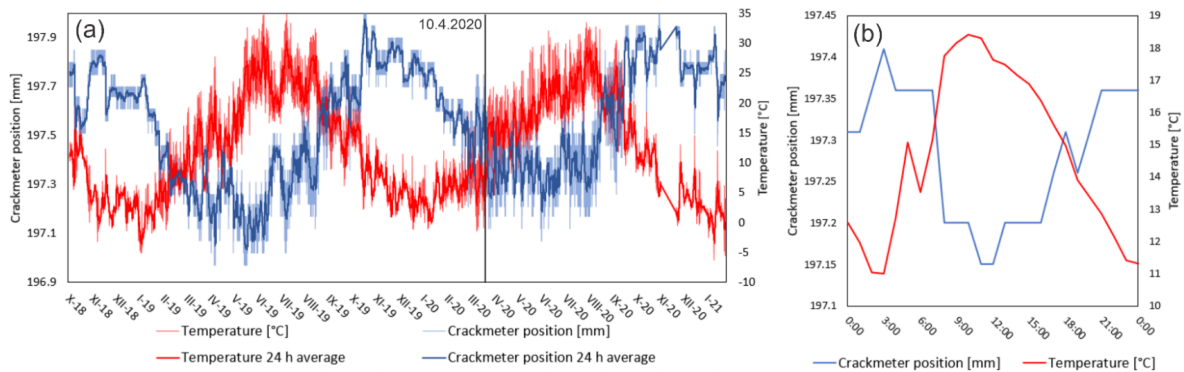
Figure 7. Measured in situ temperature and crack opening at the Pastýřská rock site. **(a)** Whole time series with annual amplitudes, **(b)** example of the diurnal amplitude measured on 10 April 2020. From the plot in panel **(a)**, the annual temperature and crackmeter position amplitude may be observed. The plot in panel **(b)** shows the diurnal temperature and crackmeter position amplitude.

At all of the monitored sites, a thermally induced dilatation of the individual blocks is observed. However, due to the relatively short time series, the measured crack movements do not show any irreversible trends visible on graphs. From the crackmeter data, diurnal and annual amplitudes of crack openings may be identified for all of the monitored rock blocks. Figure 7 shows the measured diurnal and annual rock crack openings at the Pastýřská rock site. From the graph, it is possible to see the influence of the diurnal and annual temperature changes on the position of the crackmeter. Similar behaviour was observed within all of the monitored blocks.

The three sites will be continuously measured for a period of 1–2 years. Based on this, we will be able to show that the system is capable of observing the influence of thermal stress on the response of the monitored blocks (Fig. 7). However, to exclude seasonality, the time series of the crackmeter positions should be longer than 2–3 years. In a longer period, we expect to observe the process of long-term rock slope destabilisation represented by a gradual irreversible trend of crack opening/closure, which alludes to partial block destabilisation. Longer time series also allow seasonal statistical trend tests to be used to describe trends in the monitored joint dynamics. The influence of meteorological variables on the stability of the rock blocks will be statistically analysed to determine how individual meteorological variables influence the dynamic of the joints. In-depth temperatures will be analysed to find differences in thermal conductivity, diffusivity, and seasonal temperature trends between the monitored sites. Differences in the thermomechanical behaviour of the different rock slopes will be studied using numerical modelling. Furthermore, the monitoring system will be continuously upgraded. Installation of in situ strain gauges is planned to directly observe changes in the rock mass surface strain.

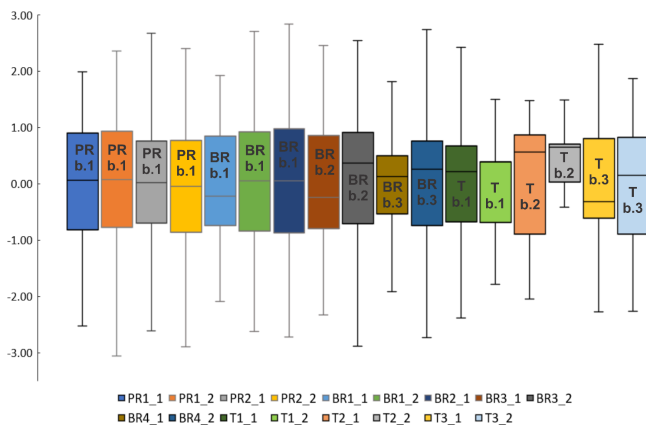
Figure 8. Boxplots of crackmeter position data. To compare the different positions of the measurements, the data were standardised. The boxplots show the max/min of the crackmeter position, median, first, and third quartile. The abbreviations inside the boxplots define the crackmeter locations. PR: Pastýřská rock, BR: Branická rock, T: Tašovice. Specific blocks are defined by numbers b.1–b.3. These correspond to the blocks displayed in Fig. 3.

The amplitude of the position of the crackmeters differs between the individual sites and blocks (Table 4, Fig. 8). These differences are caused by different blocks dimensions, time series length, crackmeter placement, and the regime of destabilisation.

To date, crackmeter amplitudes (Fig. 8, Table 4) higher than 1 mm have been measured on Block 1 (approximately 170 m³) at the Pastýřská rock site (PR1_1, PR1_2), and on Block 1 (approximately 16 m³) at the Branická rock site (BR1_1, BR1_2, BR2_1). These blocks are the two largest instrumented. The measured crackmeter amplitude is reversible and is therefore caused by thermal expansion/contraction of the block. The relatively small Block 3 at the Branická rock site (BR4_1, BR4_2) shows movements larger than 0.5 mm, although it has only been instrumented since the summer of 2020. Such a large amplitude suggests that the block is unstable, and this hypothesis should be confirmed by further monitoring.

The blocks instrumented at the Tašovice site seem to be more stable (Table 4, Fig. 8). Only Block 3 shows 0.85 mm of reversible movement. By further analysis of the graphs and statistical trends, possible irreversible trends of the blocks should be revealed. Destabilisation of a single block should be visible as irregularities in the time series of the position of the crackmeter not strictly related to thermal dilatation. Two crackmeters at the Tašovice site show large amplitudes of movement (T2_2, T3_2); however, these move-
