The Impact and Resolution of the GPS Week Number Rollover of April 2019 on Autonomous Geophysical Instrument Platforms

2 Fault Description

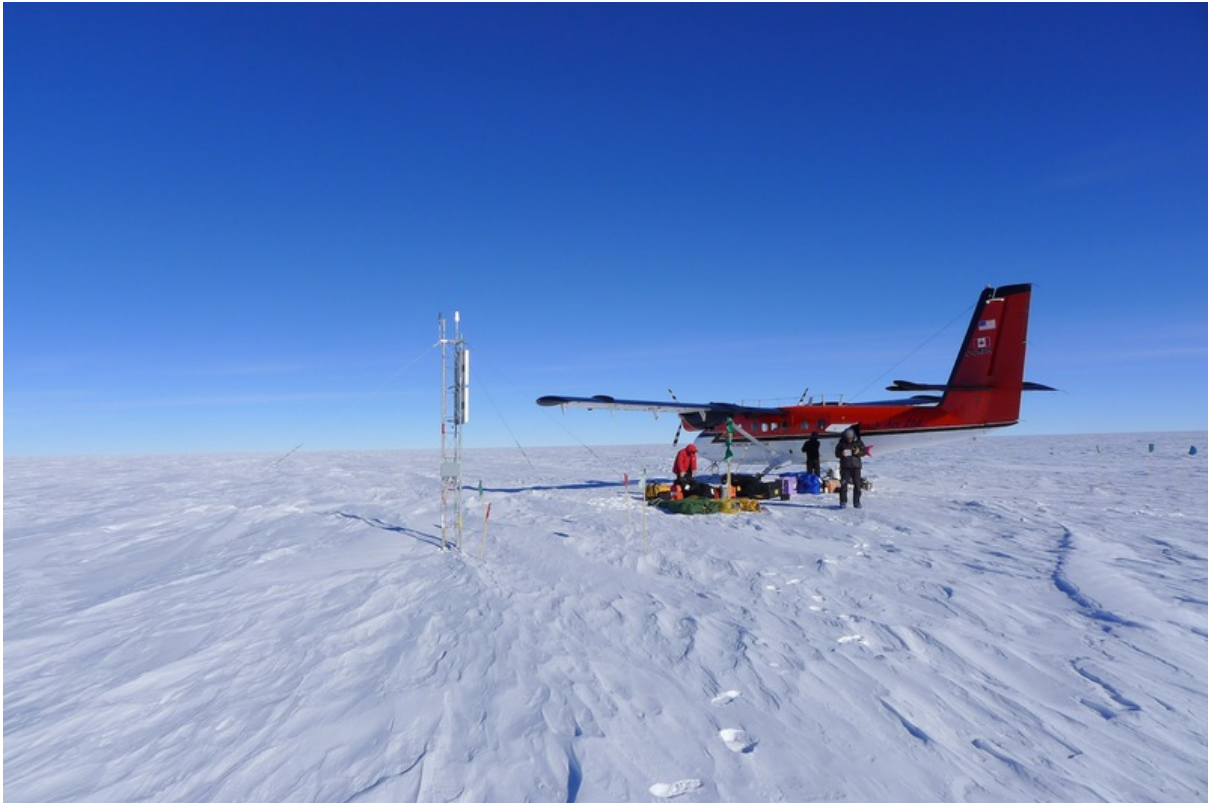
Figure 1. Twin Otter airplane next to the AAL-PIP system at PG2 (84.42 S, 57.96 E). The extreme environment and remote nature of the AAL-PIP sites makes in-person maintenance very difficult.

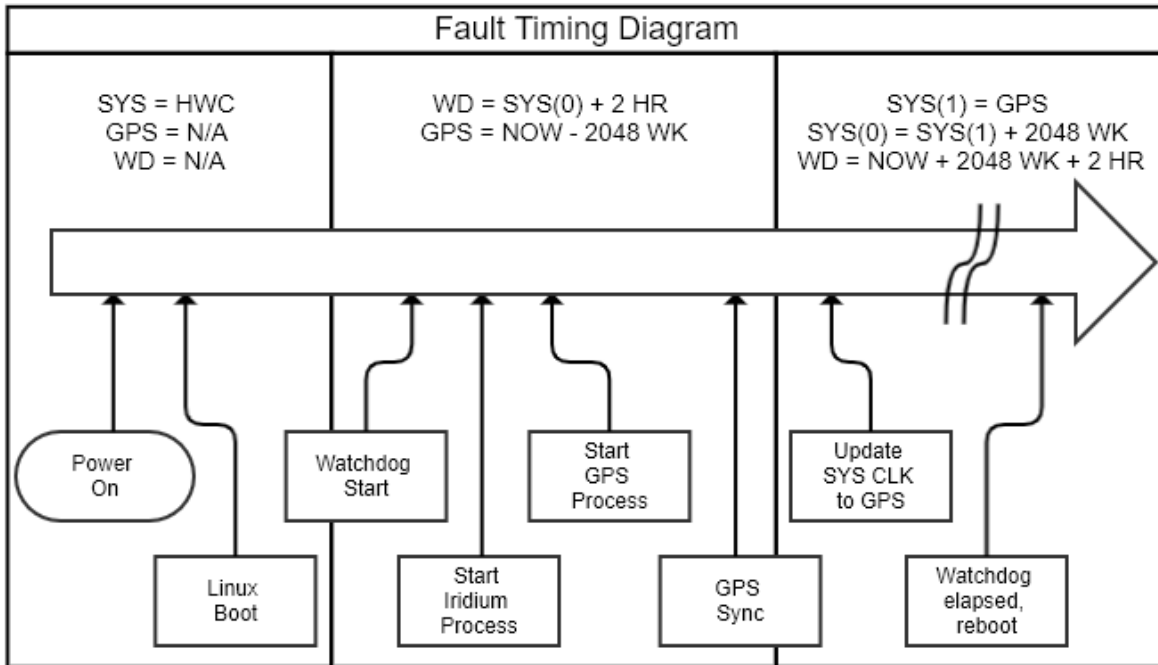
Figure 2. [Diagram showing the process of updating the multiple clocks on an AAL-PIP. After the Linux OS finishes initialization, the AAL-PIP software sets the watchdog \(WD\) timer and spawns separate processes for communication and GPS synchronization. In this diagram, SYS\(0\) refers to the value of the system clock after boot, whereas SYS\(1\) is the system clock value after GPS sync. The fault occurs in block three, where the system clock SYS\(1\) is set to the erroneously offset GPS time.](#)

During simulated operational testing of the hardware onsite in Blacksburg, VA, it was determined that the GPS module was providing an erroneous date and time. A constant negative offset of 2048 weeks was found, which is consistent with the GPS rollover period. Further analysis discovered the source of the communications fault, which occurs as a result of updating the system time while an active communications link is established. A communications watchdog is supposed to monitor unusual circumstances relating to "hung" or stalled communications links, but the watchdog relies on the system clock and is effectively disabled because of the bug. The process of determining how much time has elapsed between successful communications attempts is a simple ~~subtractions~~subtraction of a watchdog start time from the current system clock time. However, when the

135 system time went through its update process, it set the system clock back 19 years, and the subtraction to determine the elapsed time yielded a negative result. In the case of the AAL-PIP watchdog, an elapsed time of two hours without successful communications will trigger the watchdog. For the bugged negative result to ever reach that threshold after the fault occurs would take 19.6 years and two hours. [This process of updating clocks and watchdogs is illustrated in Figure 2](#)

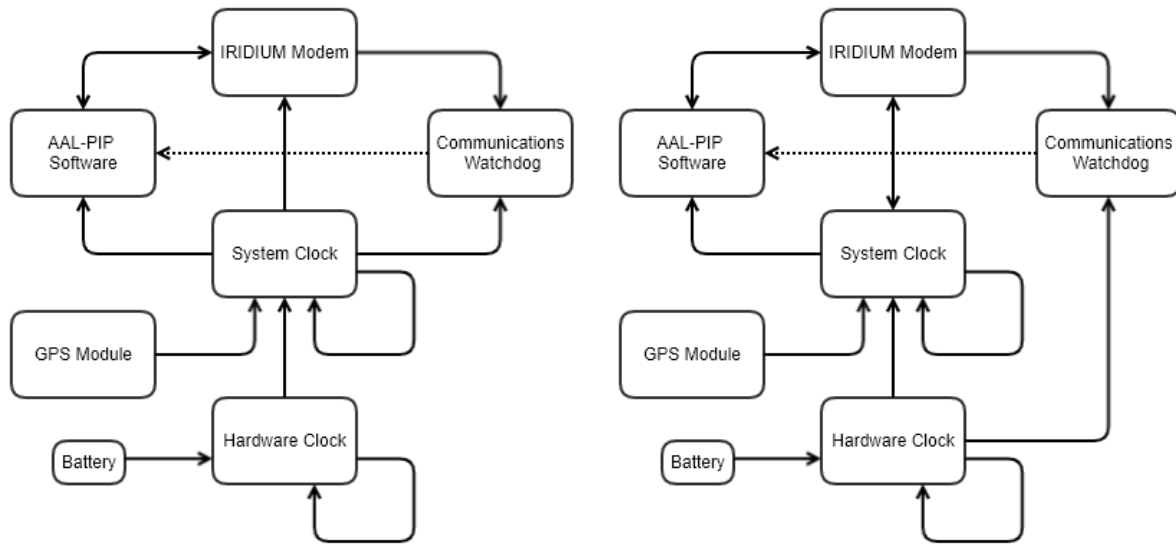
Figure 3. Diagrams contrasting the original flow of time information on the AAL-PIP systems (left) with the current method (right). Note the use of the hardware clock as an input for the communications watchdog, as well as the availability of IRIDIUM network sourced time for the system clock. The dotted line represents a reset signal presented by the watchdog.

to the current GPS epoch start date. Second, if the date was incorrect, the reported difference in date and time had to be offset, in this case by simply adding a constant value to the recovered value. This software patch was developed in December of 2019 in advance of the austral summer field season. Figure 3 shows the differences in timing information flow within the AAL-PIP systems as a result of this patch. The first attempt to deploy this fix would require a manual power cycle of the remote system, something not achievable without ground support.
