Observation of the rock slope thermal regime, coupled with crackmeter stability monitoring: initial results from three different sites in Czechia (Central Europe)

Ondřej Racek^{1,2}, Jan Blahůt², Filip Hartvich²

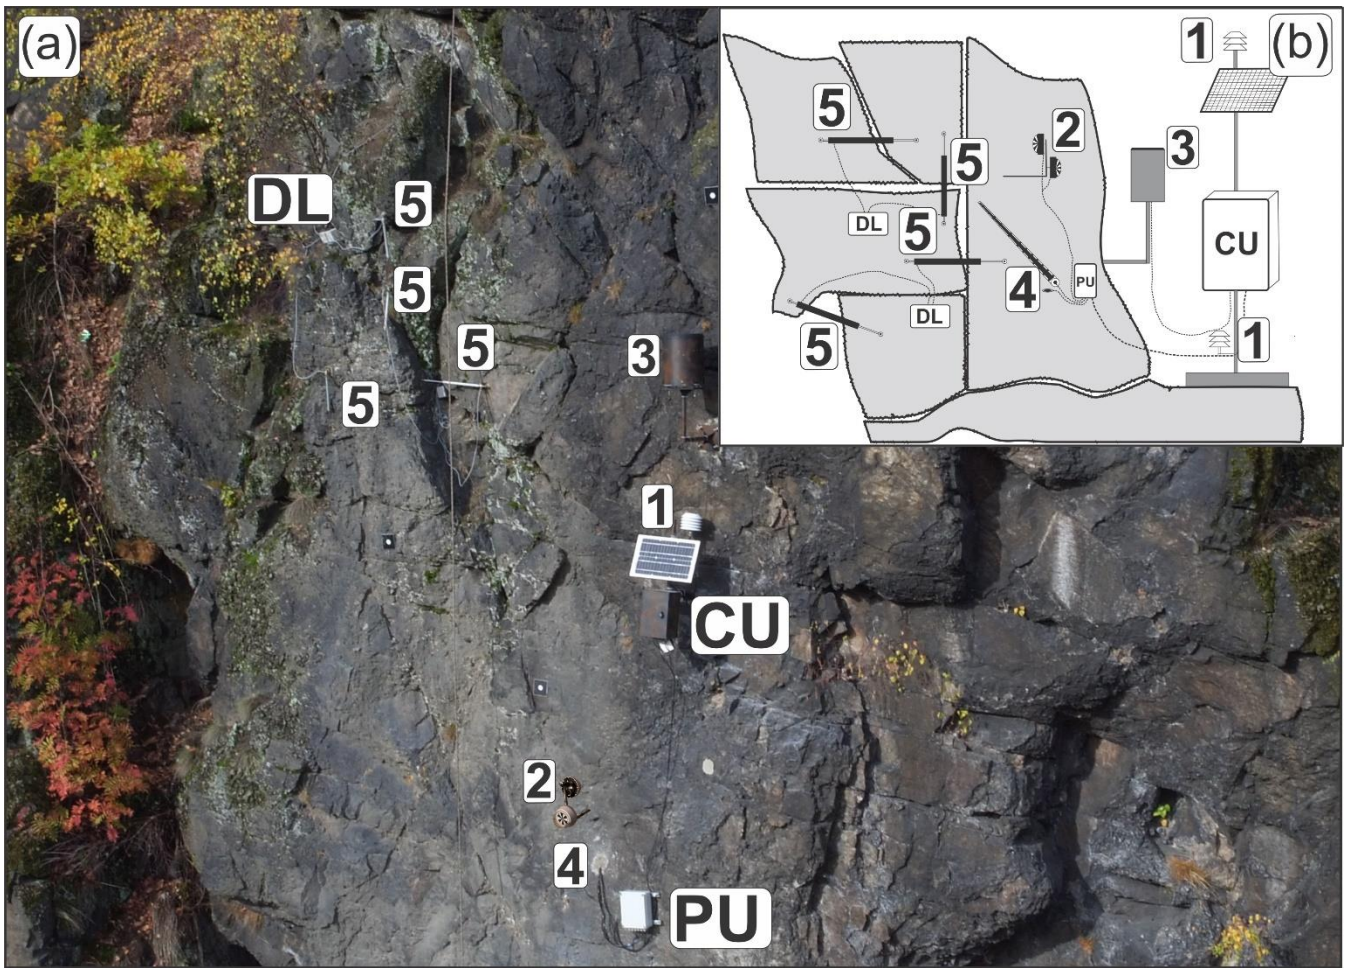
115 **Figure 1** Photo of the monitoring system at the Tašovice site (a) generalised scheme of the monitoring system (b) CU: control unit, PU: processing unit, DL: datalogger, 1 Temperature sensor, 2: Pyranometers, 3 Rain gauge, 4 Borehole compound temperature probe, 5 Crackmeters (only four of a total of six crackmeters are visible on this photo)

- A set of automatic induction crackmeters, coupled with dataloggers (Fig. 1) measuring relative block displacement
- A weather station with a set of sensors measuring various meteorological data (Fig. 1), such as air temperature, humidity, and air pressure (Table 1), and surface solar radiation balance (incoming/reflected radiation) of the rock face (Fig. 5) using a pair of pyranometers
- A set of 12 thermocouples placed along a 3 m deep borehole (Fig 2.), carefully insulated between each neighbouring sensor, measuring in-depth profiles of the rock slope temperature

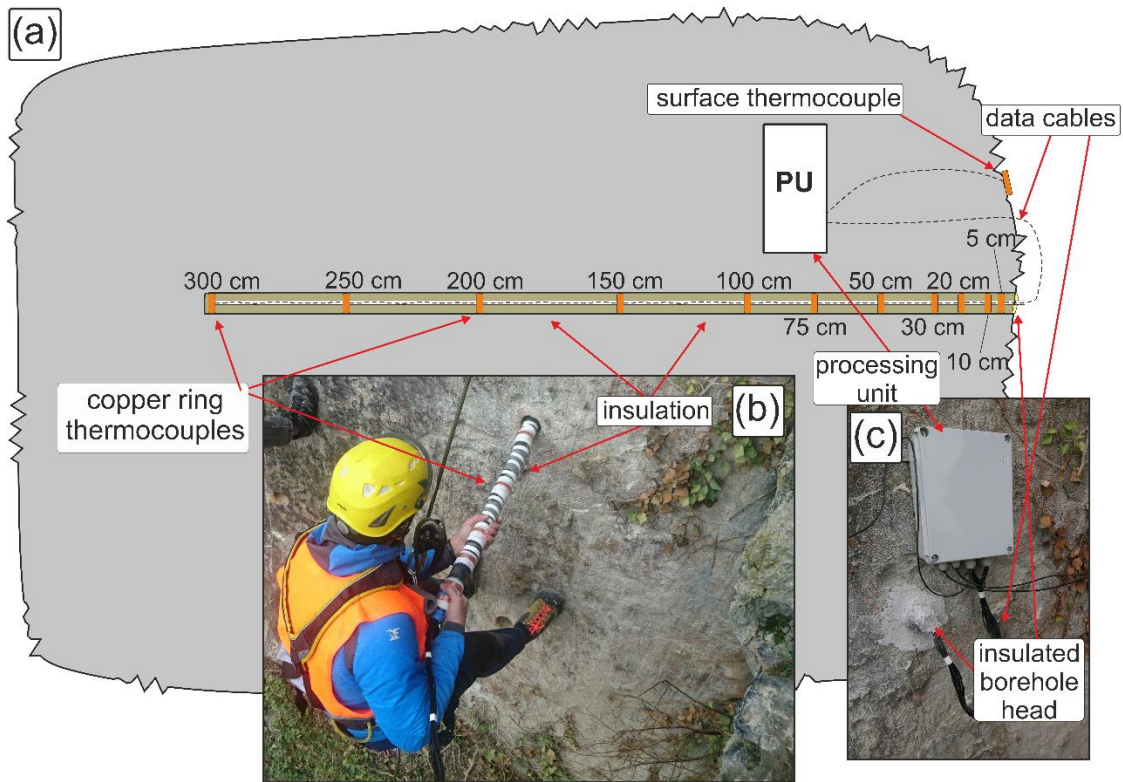
175 **Figure 2 Compound borehole thermocouple probe. (a) generalised scheme, (b) photo of compound thermocouple probe installation, (c) insulated head of a sub-horizontal borehole with a processing unit.**

For the monitoring of the thermal behaviour of a rock slope, it is necessary to know temperatures at different depths of the rock mass. The newly designed in-depth compound temperature probe (Fig. 2) is a crucial part of our monitoring system. The sensors are placed in a 3 m deep sub-horizontal borehole. To ensure safety during drilling and the long lifespan of the 160 borehole and sensors, the borehole itself is drilled into a stable part of the rock slope. The borehole is then equipped with a custom-designed probe with a set of thermocouples. The technical parameters of the temperature sensors are the same as for the air temperature sensors (Table 1). The thermocouple sensors that are connected to copper rings were originally designed for soil temperature measurements. By connecting these to copper rings, they are suitable for measuring the temperature of borehole walls. Copper rings with 5 cm diameter are placed at a given distance on the tubular spine (5 cm below the surface, 165 10 cm, 20 cm, 30 cm, 50 cm, 75 cm, 100 cm, 150 cm, 200 cm, 250 cm, and 300 cm). The probe is placed in the sub-horizontal borehole, so the copper rings containing the temperature sensors lay directly on the borehole walls (Fig. 2). This ensures that the probe is directly measuring the rock mass temperature. Additionally, one thermocouple is placed directly on the rock surface (Fig. 2). The head of the borehole is insulated to prevent air and water inflow into the rock and the sensors inside the borehole are separated by thorough thermal insulation to ensure that the temperatures are not affected by the air circulation 170 inside the borehole. Therefore, temperature readings from the borehole compound probe correspond to the in-situ rock mass temperature. The thermal data, collected every 10 minutes, are passed through a converter, and sent to the main control unit of the environmental station.

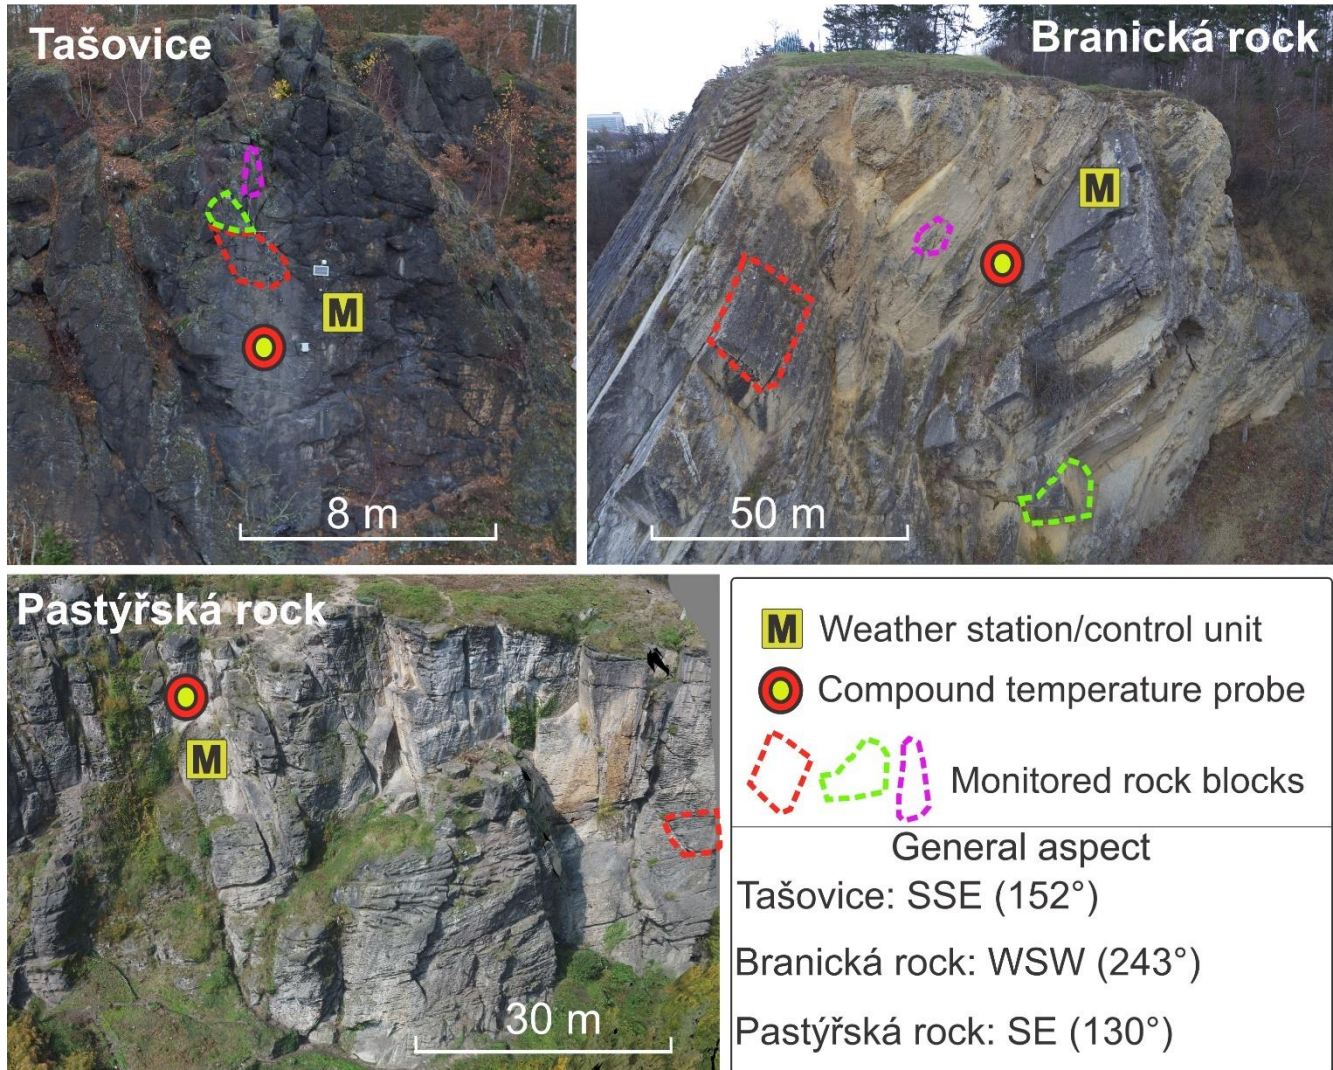
185 **Figure 3** Three instrumented rock slope sites. On each photo, the monitored rock blocks are indicated with dashed lines of a different colour. The placement of the compound borehole temperature probe and weather station is also indicated.

180 To-date, the monitoring system has been established at three different sites (Fig. 3), using the same instrumentation setup. The sites were chosen deliberately on steep rock slopes built of various rock types, with various slope aspects and a diverse geological history. To integrate a practical application aspect, sites were chosen where the potential rockfall endangers buildings, infrastructure, or other social assets.

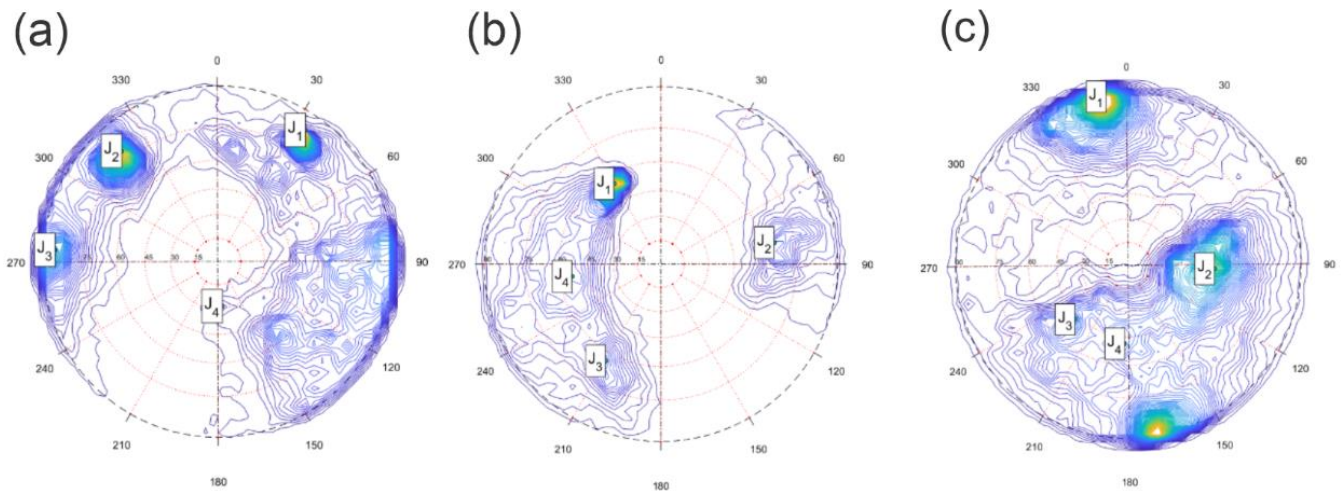
245 **Figure 4 Stereonets with the four main discontinuity sets (J1 – J4) classified using DSE software (Riquelme et al. 2014). The density of the principal poles corresponds to the main discontinuity sets identified from the point clouds. (a) Pastýřská rock, (b) Branická rock, (c) Tašovice.**

255 From the discontinuity analysis (Fig. 4), it is possible to see that in the case of the Pastýřská and Branická rock sites the discontinuity systems are clearly defined. The discontinuity sets at these sites are defined mainly by sedimentary layers and cracks perpendicular to them. In the case of the Tašovice site, the discontinuity systems are less pronounced. At this site, discontinuities are linked mainly to tectonically predisposed weak zones and weathered parts of the granite rock. The mechanical properties of the rock mass samples (Table 3) differ significantly according to the degree of weathering. The best results in terms of hardness were obtained from the unweathered limestone from the Branická rock site. The lowest hardness was determined for the weathered sandstone from the Pastýřská rock site. At the Tašovice site, it was not possible to call an unweathered sample due to the high degree of weathering of the whole rock slope.

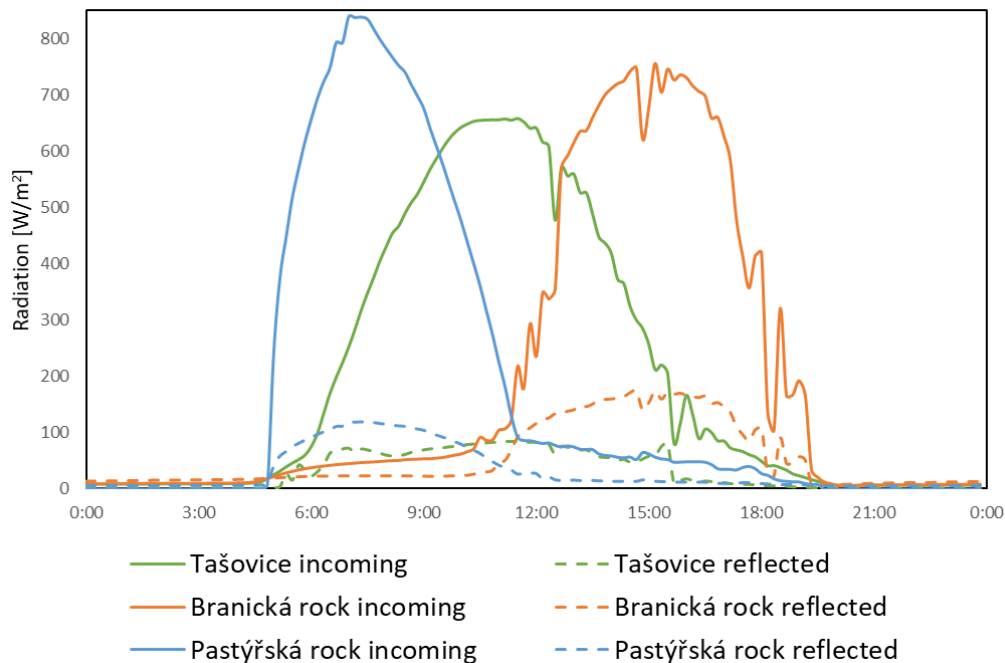
Figure 5 Example of the incoming and reflected radiation measured by the pyranometers at the Branická rock, Tašovice and Pastýřská rock sites. A 24-hourtime series of incoming and reflected radiation is displayed. Data were recorded on 1 August 2020 with no clouds. The influence of the slope aspect is obvious from the incoming radiation peak shift.

270 The rock surface solar radiation balance was monitored at the sites in 2020 (Branická rock in January, Pastýřská rock in February, and Tašovice in December). Even from these incomplete data it is possible to observe the differences between the individual sites (Fig. 5). Local conditions influence the incoming radiation pattern based on the general aspect of the rock slope (temporal shift of incoming radiation peak), rock slope albedo or the shading effects of the surroundings of the pyranometers. Differences in the absolute reflected radiation are mainly caused by the different colours of the rock faces, and by the different angle of incoming solar radiation due to the aspect of the instrumented slab.

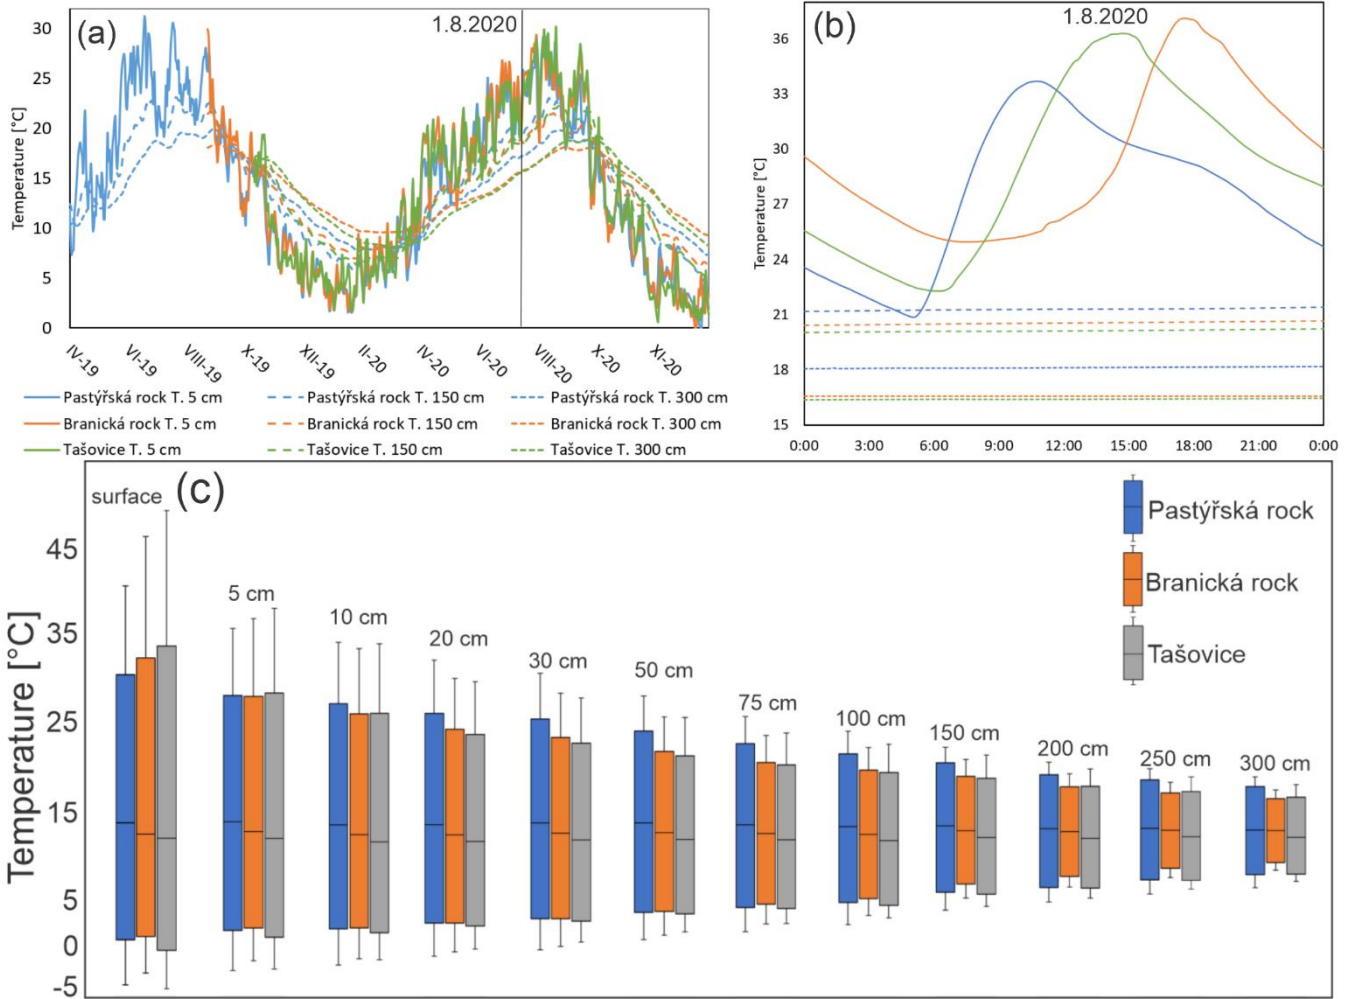
295 **Figure 6 Comparison of temperatures at different rock slope depths (5, 150, and 300 cm) at the three monitored rock slope sites. (a) long-term data (daily average), (b) one day data from 1 August 2020. In depth annual (a) and diurnal (b) temperature amplitudes are displayed. In-depth rock mass temperature data from all three monitored sites. Boxplots shows median, minimum, maximum, first, and third quartiles of temperature data. Temperature amplitudes from the compound borehole temperature probes may be compared between sites. At all sites, a decrease in the temperature amplitude with depth is apparent. (c)**

280 By continuously measuring the temperature at different depths inside the sub-horizontal boreholes, it is possible to observe both diurnal and annual temperature amplitudes at various depths (Fig. 6). In-depth temperature measurements show differences in the temporal thermal behaviour between the monitored rock slopes (Fig. 6). From the boxplots that represent

data from all of the monitored sites, it is possible to see that the largest surface temperature variation was measured at the Tašovice site. This is probably caused by the dark colour of the Tašovice rock surface, with lower albedo. However, at greater depths, this variation decreases. This is probably caused by the lower thermal diffusivity of the granite. Moreover, in the depth of the rock mass, the influence of direct sunlight is attenuated. Greater in-depth temperature variation is present at the Pastýřská rock site. However, these data may be biased by different time-series lengths (1 vs 2 full years). The effect of different aspects may be seen in the peak of the diurnal temperature, when the temperature peaks earlier on the E facing rock slope (Pastýřská rock) than on the SSE facing Tašovice, and WSW facing Branická rock sites (Fig. 6). Differences in lithology (different thermal diffusivity) cause a temporal shift between surface and subsurface temperature peaks. This temporal shift differs between the different rock slopes. A higher median of the in-depth temperature at the Pastýřská and Branická rock sites (Fig. 6) is caused by longer in-depth temperature time-series spanning over two summer periods.

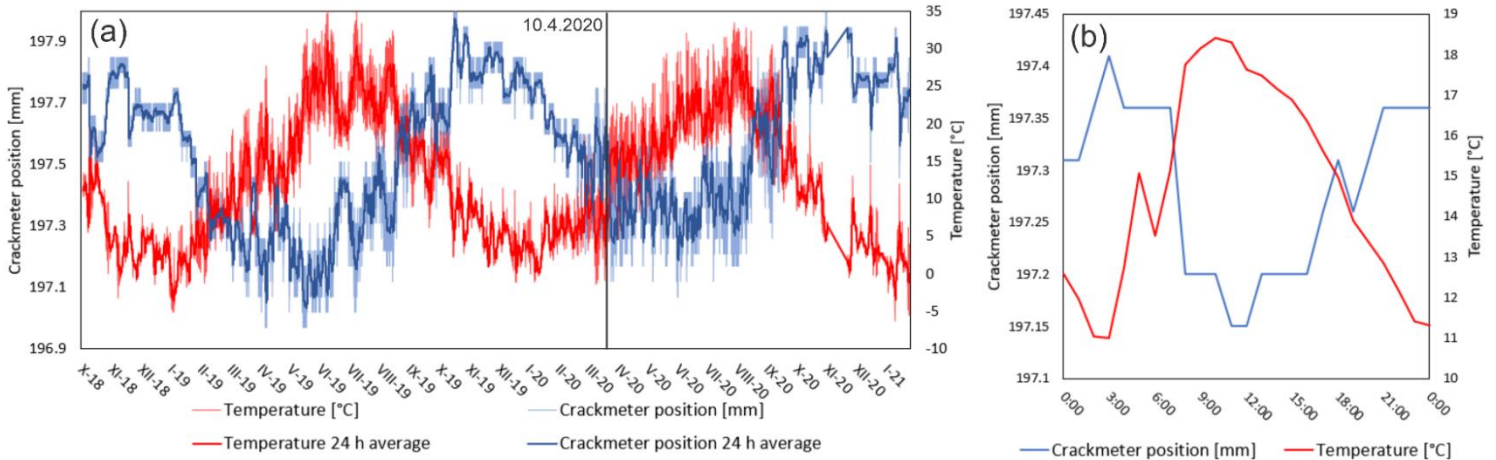
310 **Figure 7 Measured in-situ temperature and crack opening at the Pastýřská rock site. (a) Whole time series with annual amplitudes, (b) Example of the diurnal amplitude measured on 10 April 2020. From plot (a) the annual temperature and crack meter position amplitude may be observed. Plot (b) shows the diurnal temperature and crackmeter position amplitude.**

At all of the monitored sites, a thermally induced dilatation of the individual blocks is observed. However, due to the relatively short time-series, the measured crack movements do not show any irreversible trends visible on graphs. From the crackmeter data, diurnal and annual amplitudes of crack openings may be identified for all of the monitored rock blocks. Figure 7 shows the measured diurnal and annual rock crack openings at the Pastýřská rock site. From the graph, it is possible to see

the influence of the diurnal and annual temperature changes on the position of the crackmeter. Similar behaviour was observed within all of the monitored blocks.

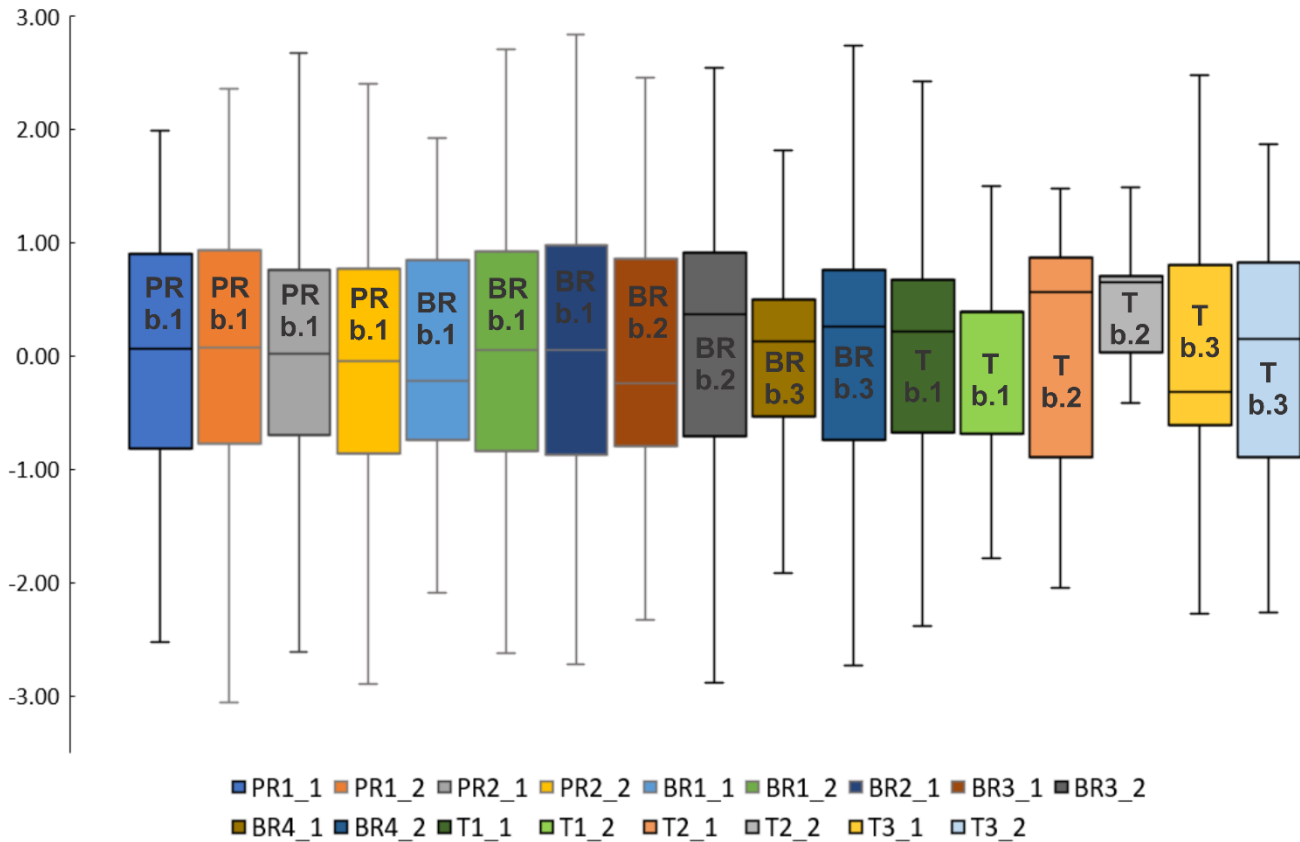
330 **Figure 8** Box plots of crackmeter position data. To compare the different positions of the measurements, the data were standardised. The boxplots show the max/min of the crackmeter position, median, first and third quartile. The abbreviations inside the boxplots define the crackmeter locations. PR: Pastýřská rock, BR: Branická rock, T: Tašovice. Specific blocks are defined by numbers b.1 – b.3. These correspond to the blocks displayed in Figure 3.

The amplitude of the position of the crackmeters differs between the individual sites and blocks (Table 4, Fig. 8). These differences are caused by different blocks dimensions, time series length, crackmeter placement and the regime of destabilisation.

To-date, crackmeter amplitudes (Fig. 8, Table 4) higher than 1 mm have been measured on Block 1 (approximately 170 m³) at the Pastýřská rock site (PR1_1, PR1_2), and on Block 1 (approximately 16 m³) at the Branická rock site (BR1_1, BR1_2, BR2_1). These blocks are the two largest instrumented. The measured crackmeter amplitude is reversible and is, therefore, caused by thermal expansion/contraction of the block. The relatively small Block 3 at the Branická rock site (BR4_1,

335 The blocks instrumented at the Tašovice site seem to be more stable (Table 4, Fig. 8). Only Block 3 shows 0.85 mm of reversible movement. By further analysis of the graphs and statistical trends, possible irreversible trends of the blocks should be revealed. Destabilisation of a single block should be visible as irregularities in the time-series of the position of the crackmeter not strictly related to thermal dilatation. Two crackmeters at Tašovice site show large amplitudes of movement (T2_2, T3_2); however, these movements were fully reversible and short lasting (one-hour measurement). They were probably caused by external forces, such as the weight of snow cover deforming the crackmeter body, or deformations of the anchoring point during maintenance. Larger blocks (PR b.1, BR b.1; BR b.2) show the largest overall amplitude of movement. The remaining smaller blocks show smaller overall amplitudes. However, these seem to be more influenced by short-term diurnal
